## **PULP & PAPER**

## Challenge

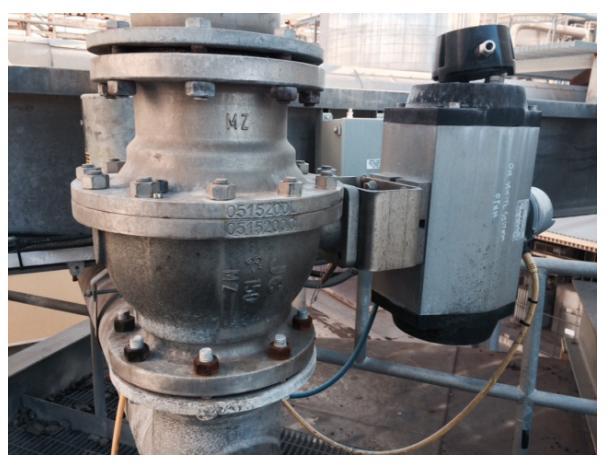
The upstream seat provided improved (Class VI) shutoff, while the downstream seat provided a scraping/wiping action of the ball

After walking down the process area and consulting with mill operations and environmental personnel, Control Southern recommended installing a Trueline double-seated ball valve with dual capabilities. The upstream seat was made of TruHard material, which would provide improved (Class VI) shutoff. A metal abrasion-resistant seat was used on the downstream side (dregs) of the valve to provide a scraping/wiping action of the ball.
